Part II Photographs – 10/2/2019
Hartsville Armory
559 West Carolina Ave. Hartsville, SC

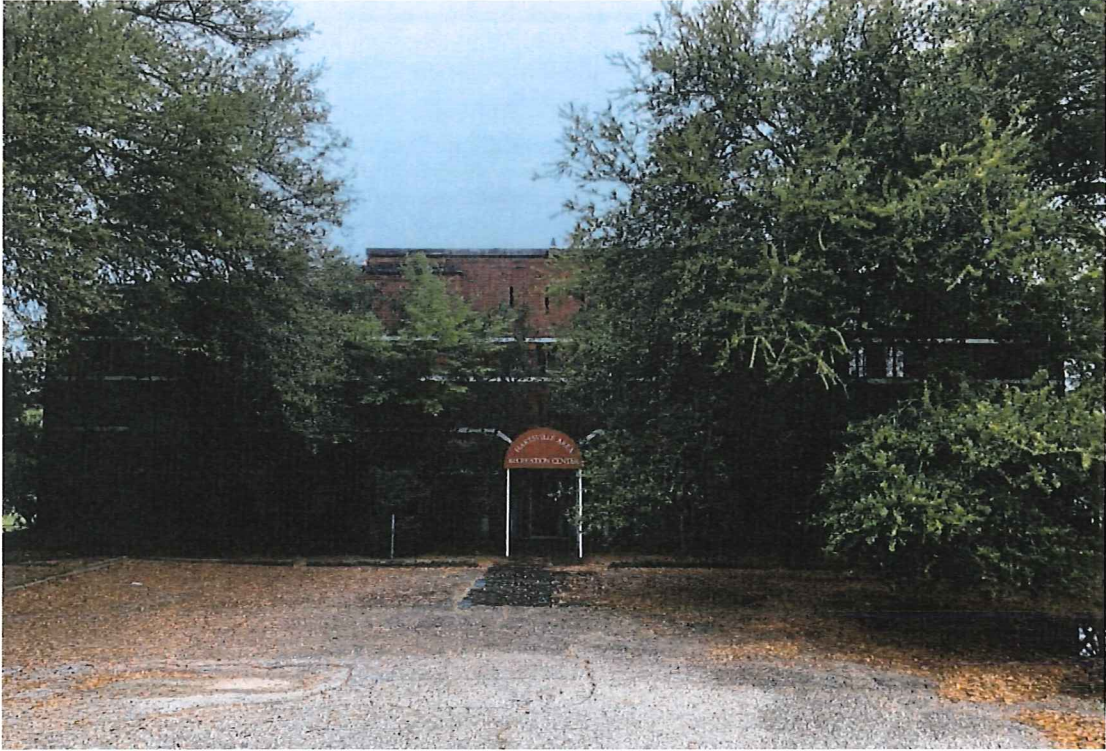
Photo 1 – North façade

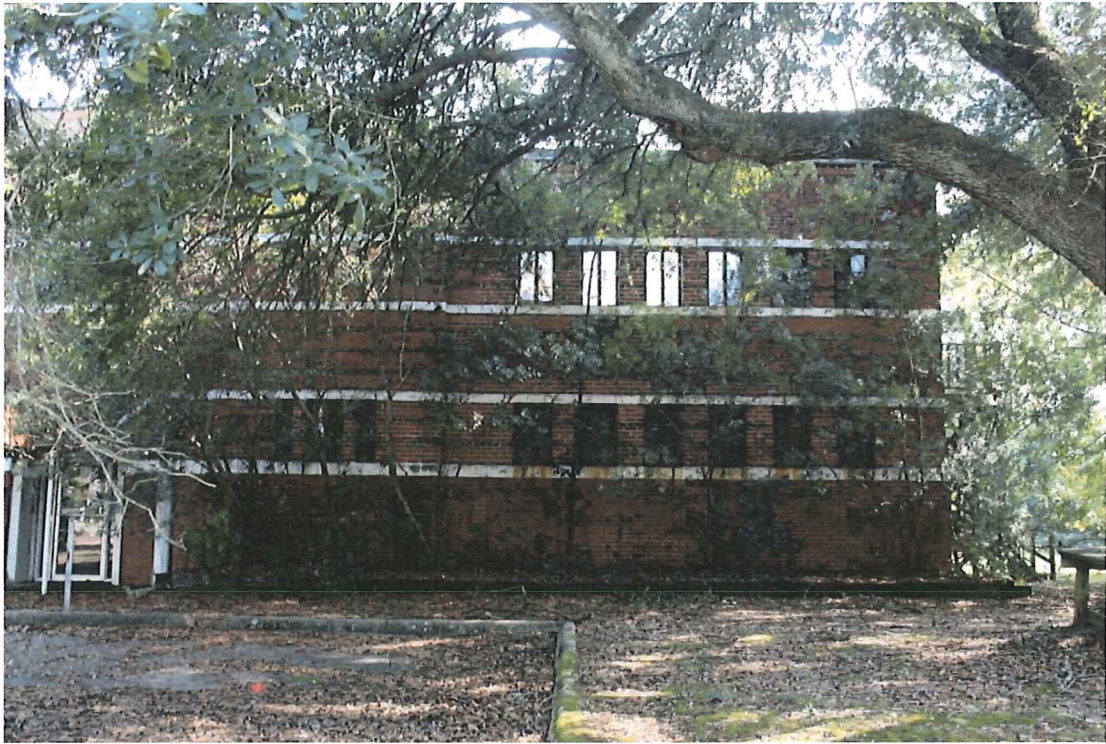
Photo 2 – West end of north façade, original windows and window pattern

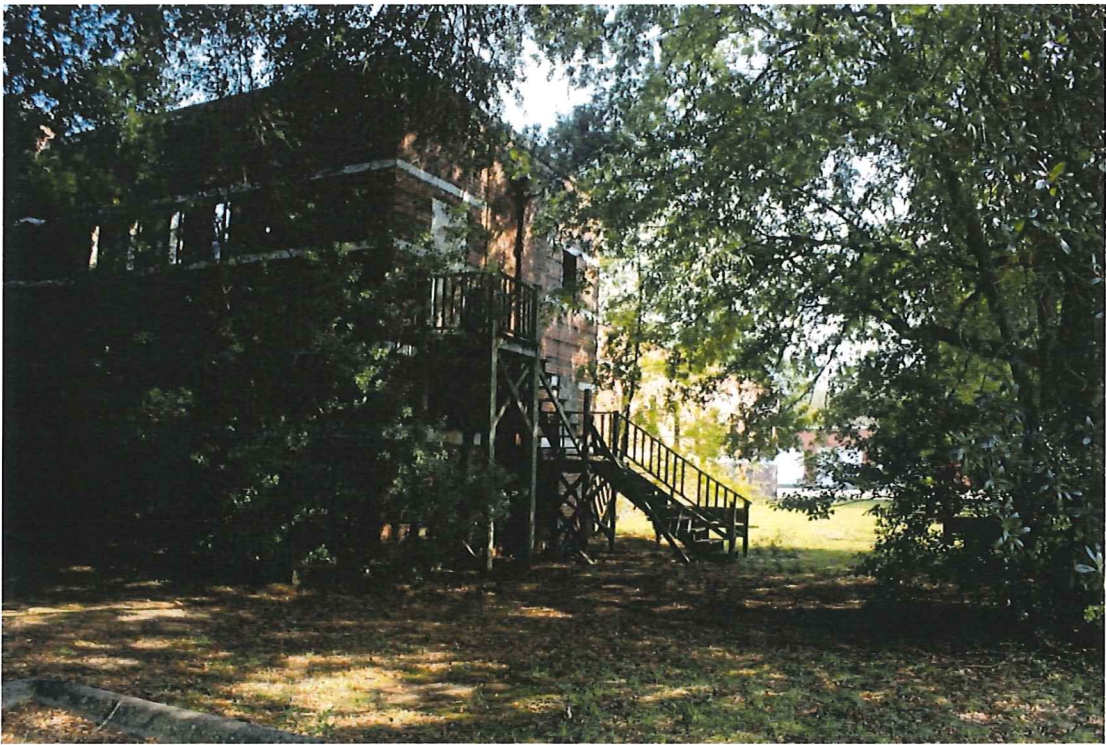
Photo 3 – West elevation with deck on administrative wing

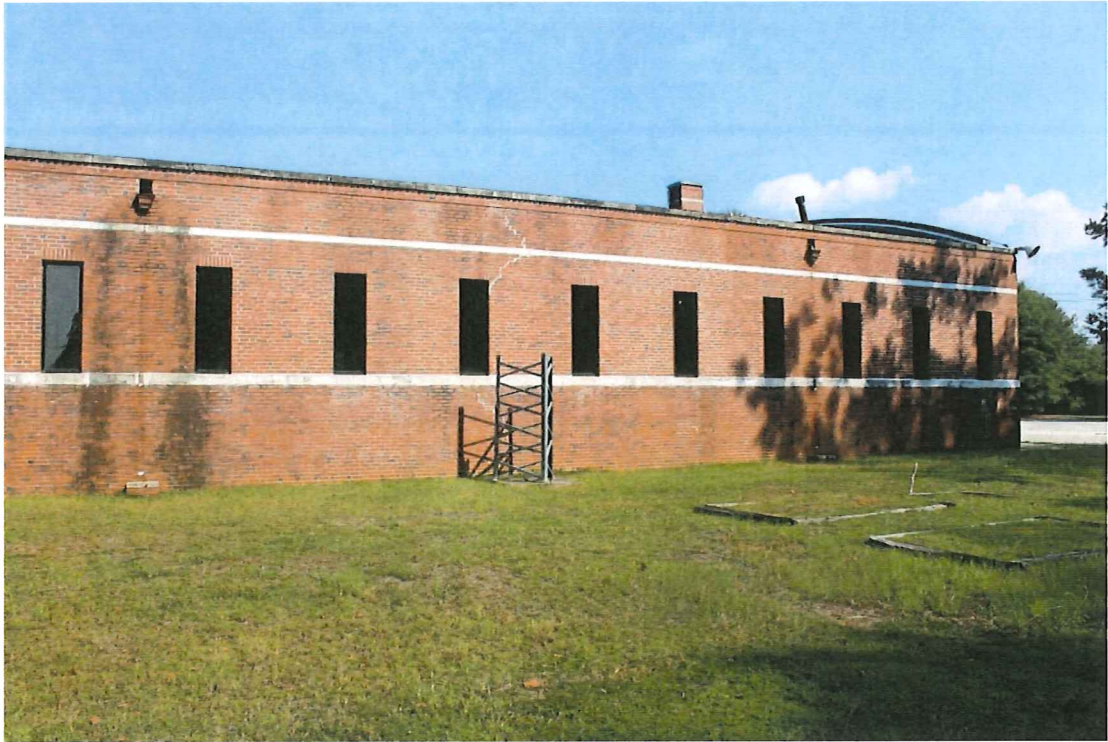
Photo 4 – West elevation of drill hall with replacement windows

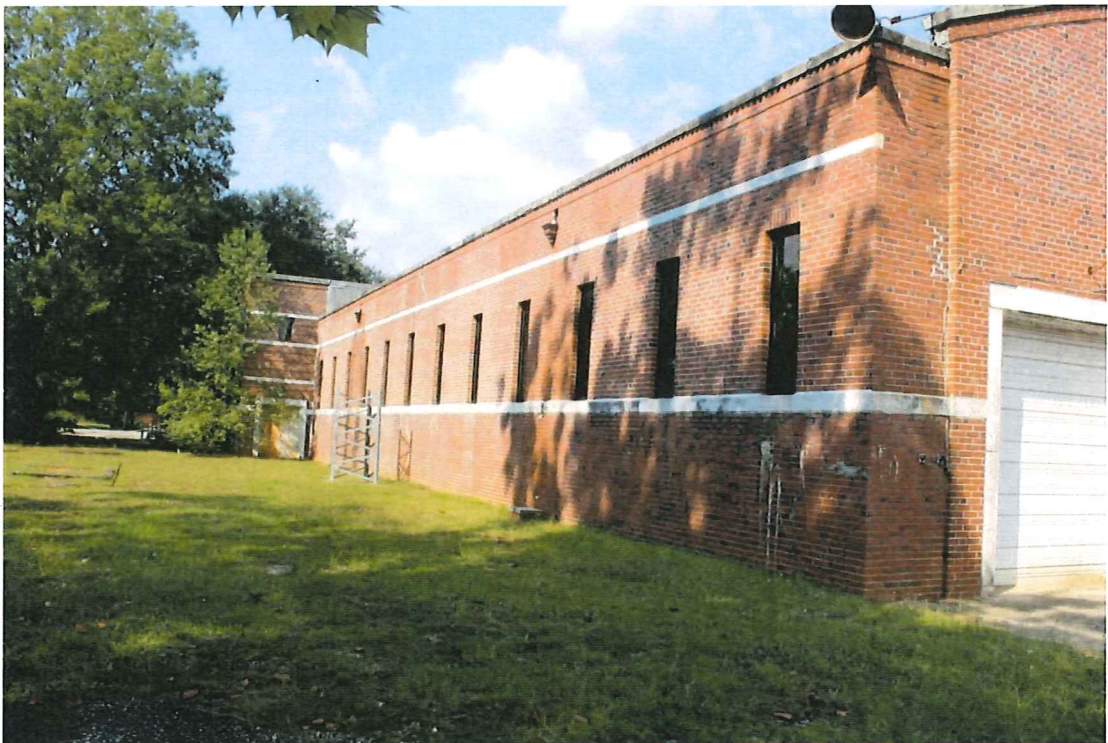
Photo 5 – West elevation looking north

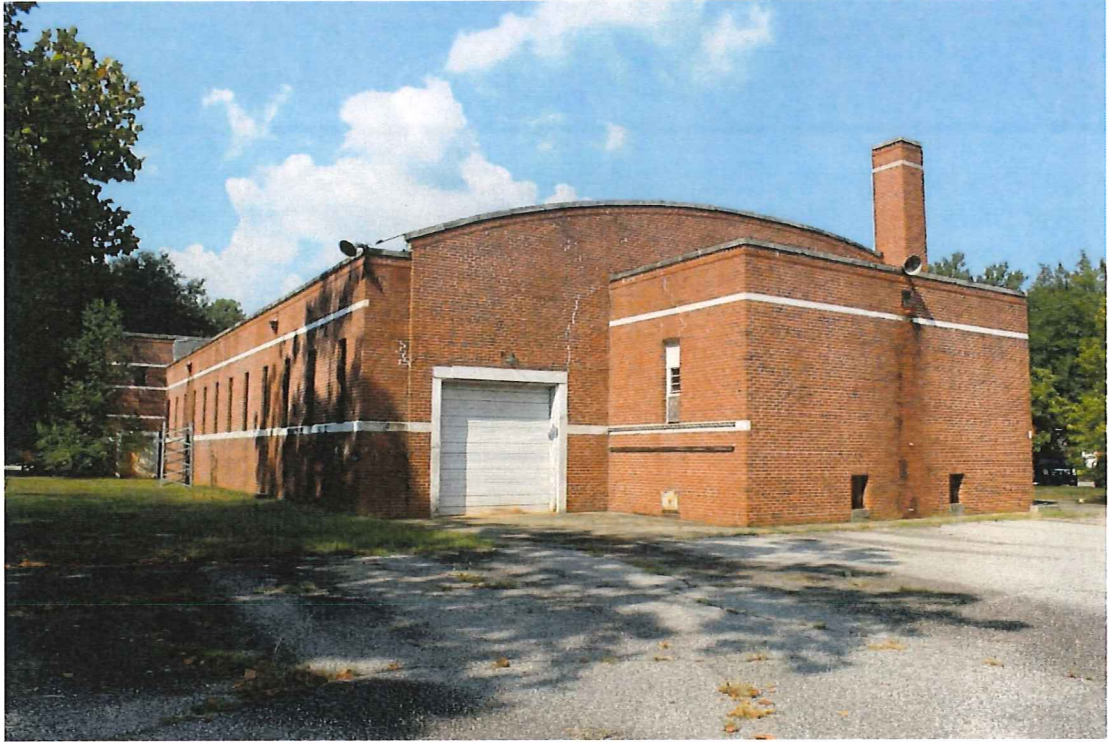
Photo 6 – Southwest oblique

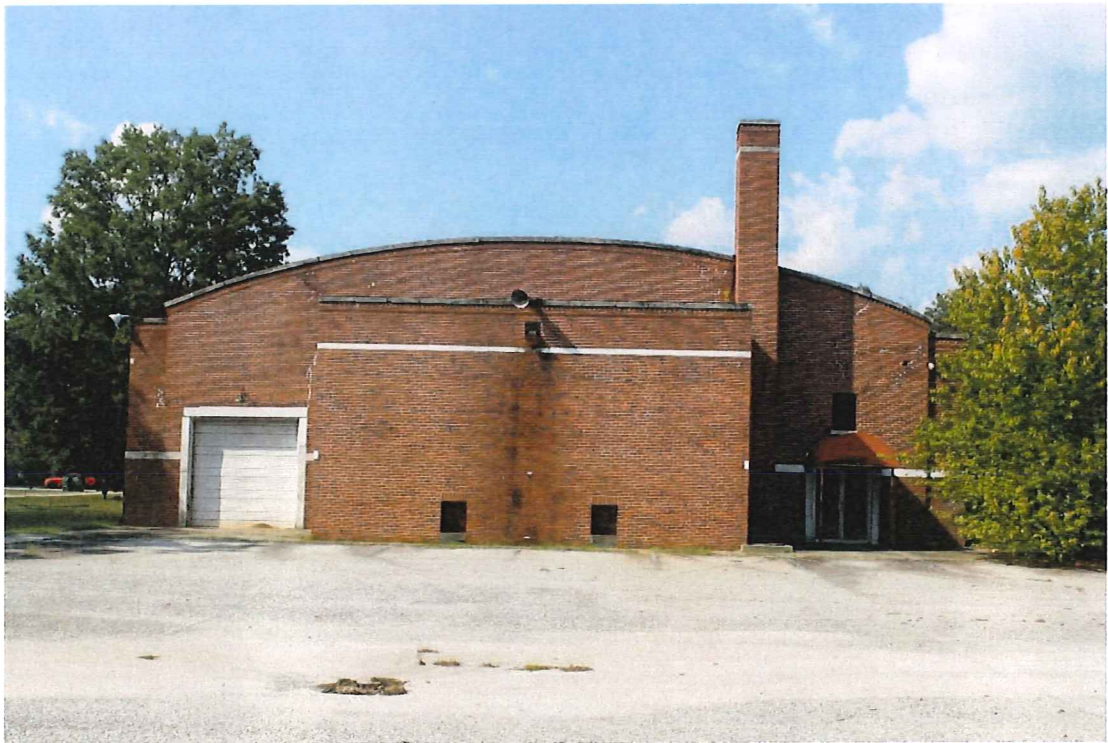
Photo 7 – South elevation

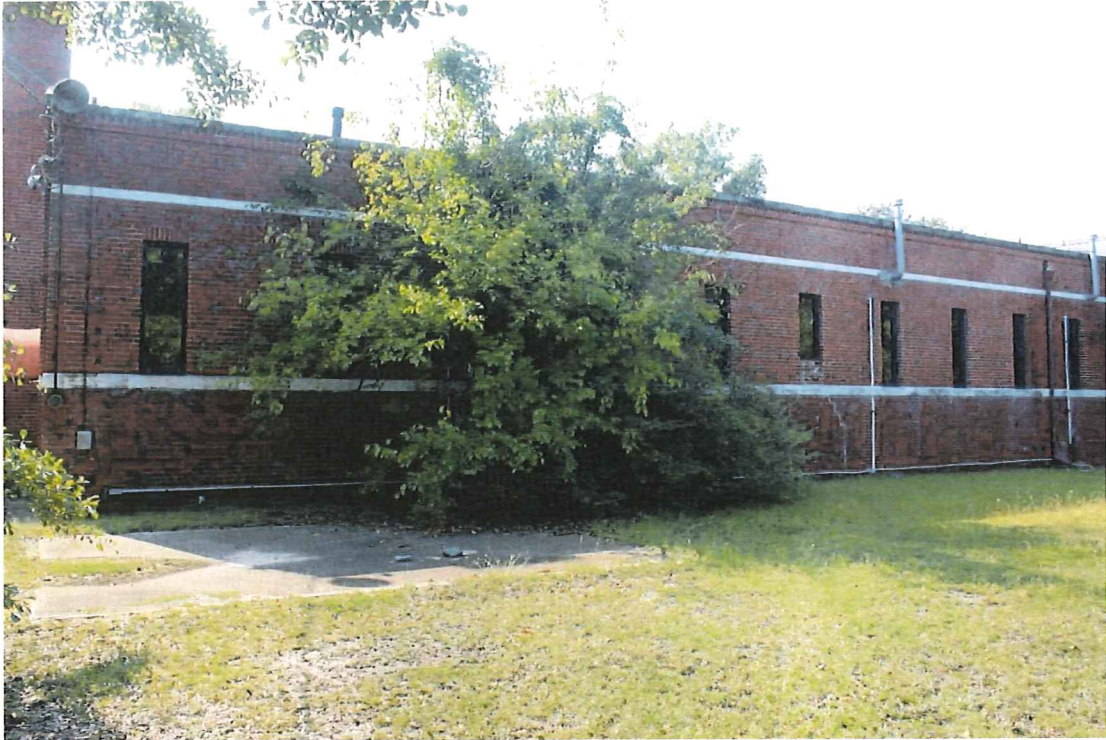
Photo 8 – South end of east elevation

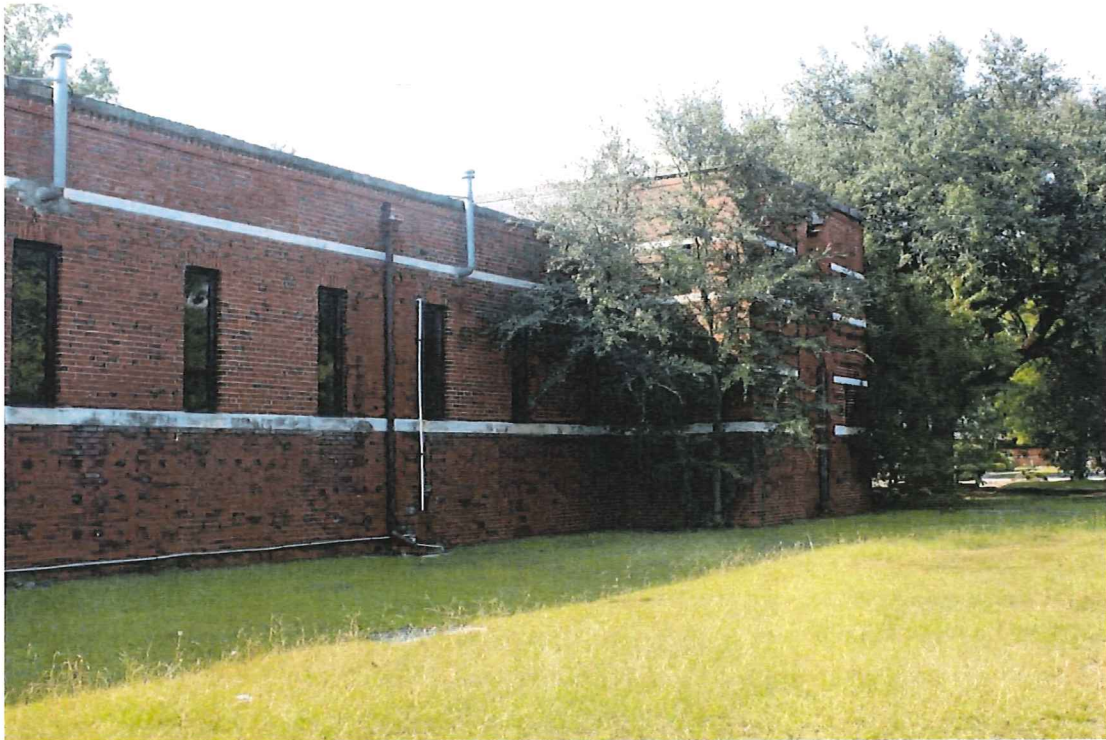
Photo 9 – North end of east elevation

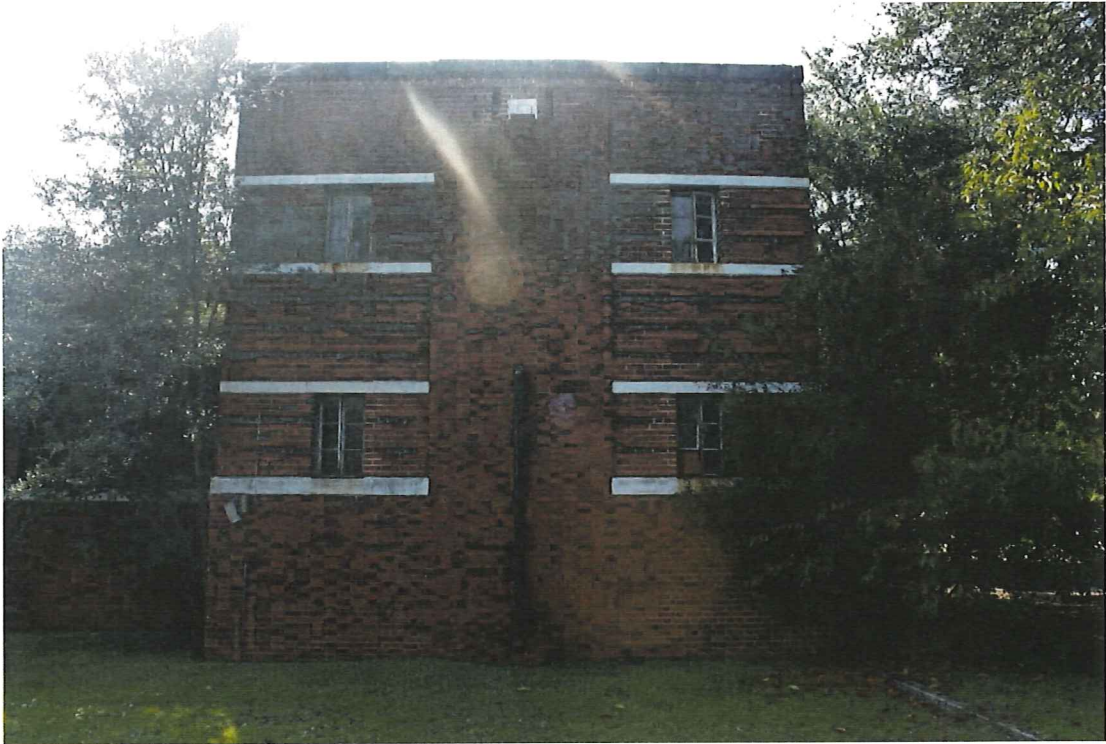
Photo 10 – East elevation of administrative wing

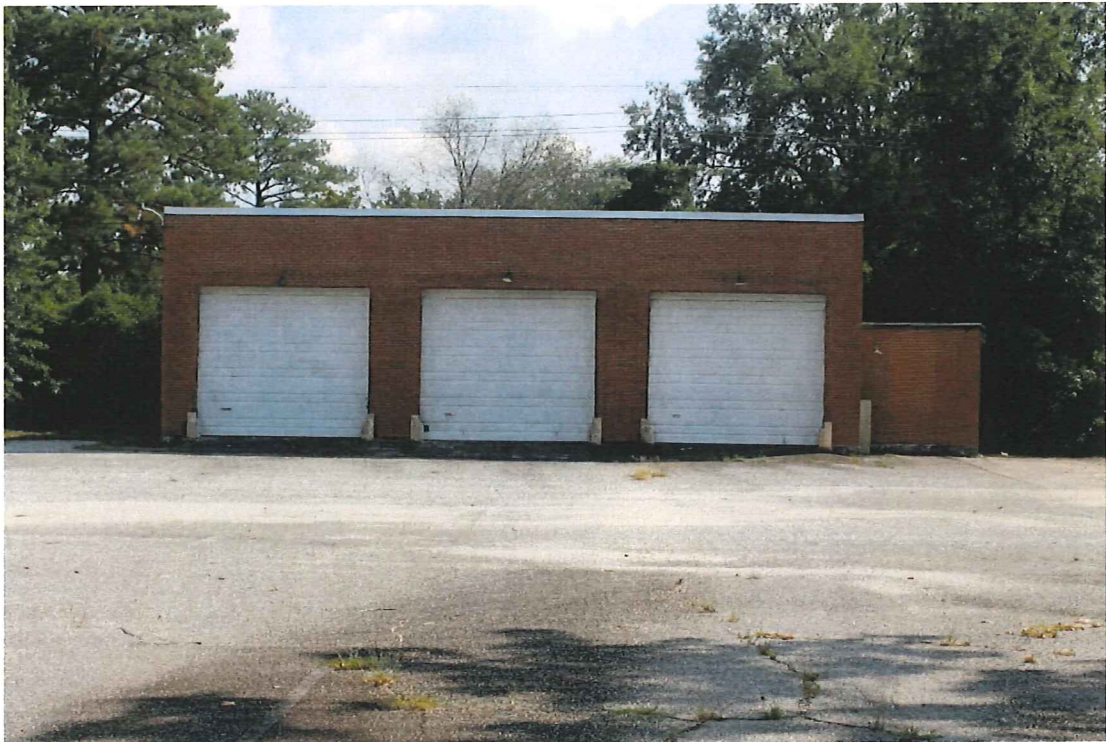
Photo 11 – Rear garage, north elevation

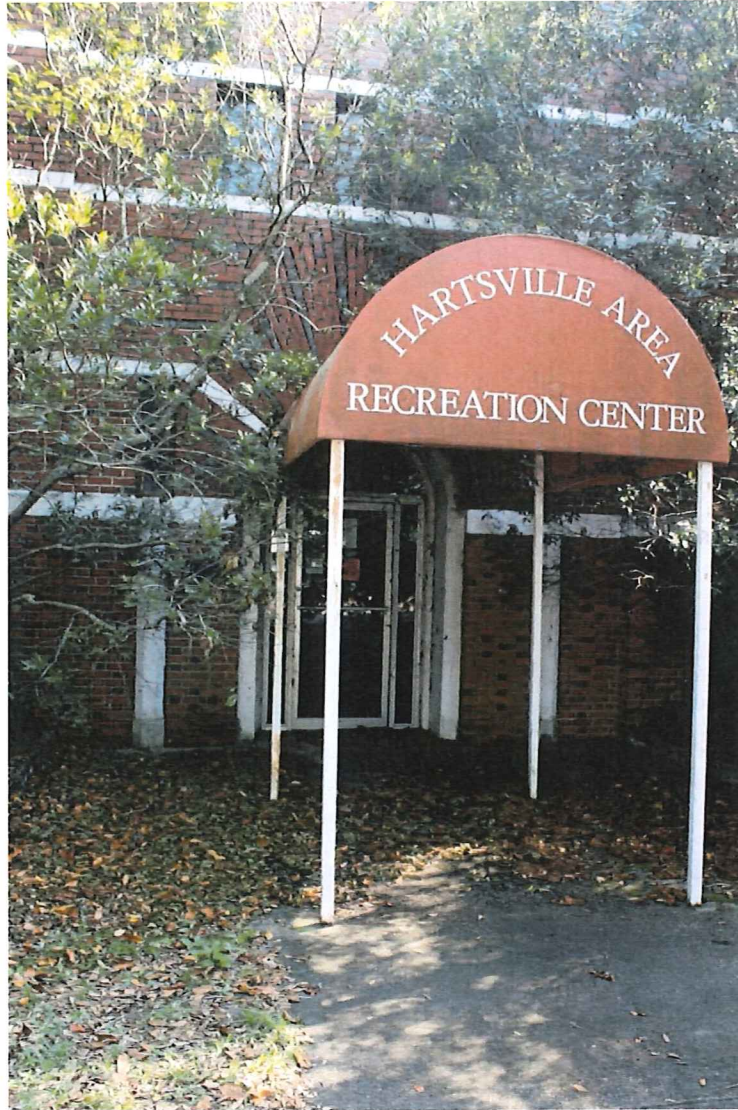
Photo 12 – Main entrance with portal and c.1981 awning

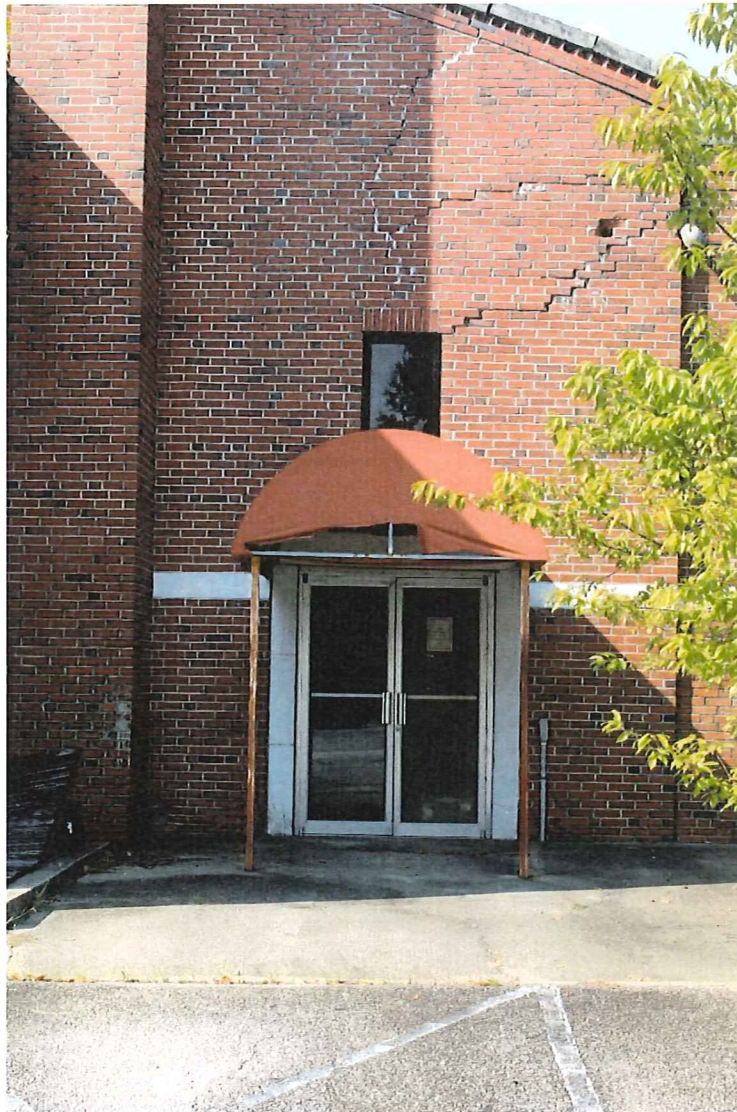
Photo 13 – Double door entrance at southeast corner

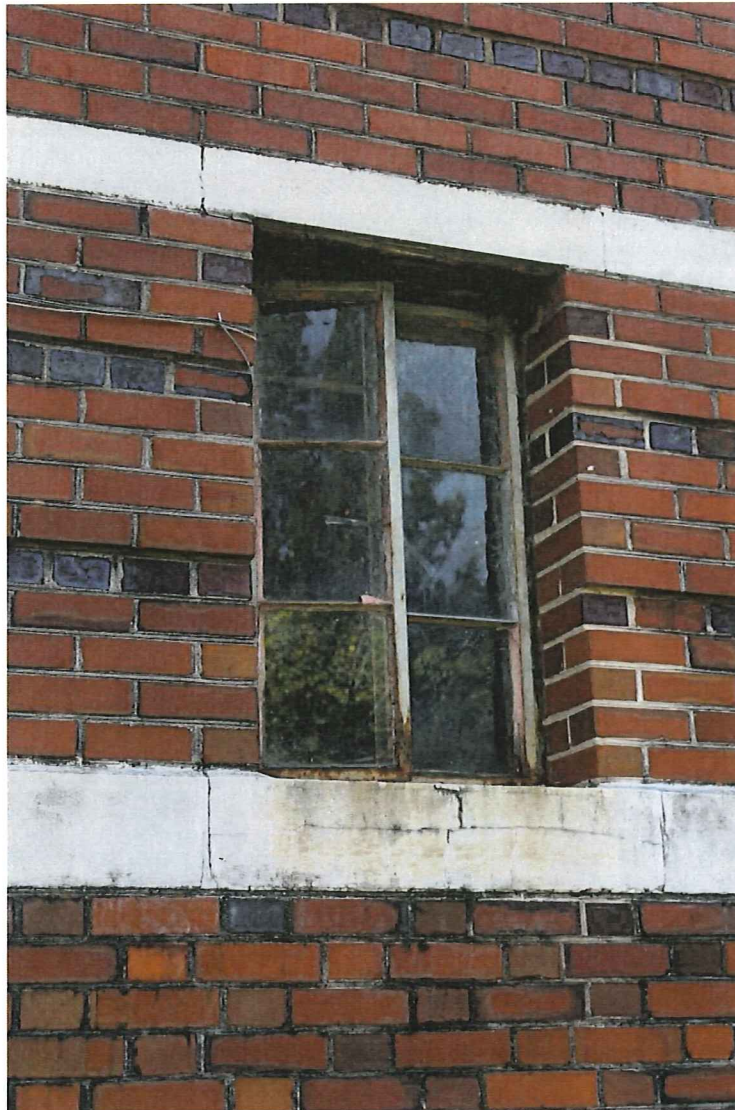
Photo 14 – Paired casement windows, west elevation

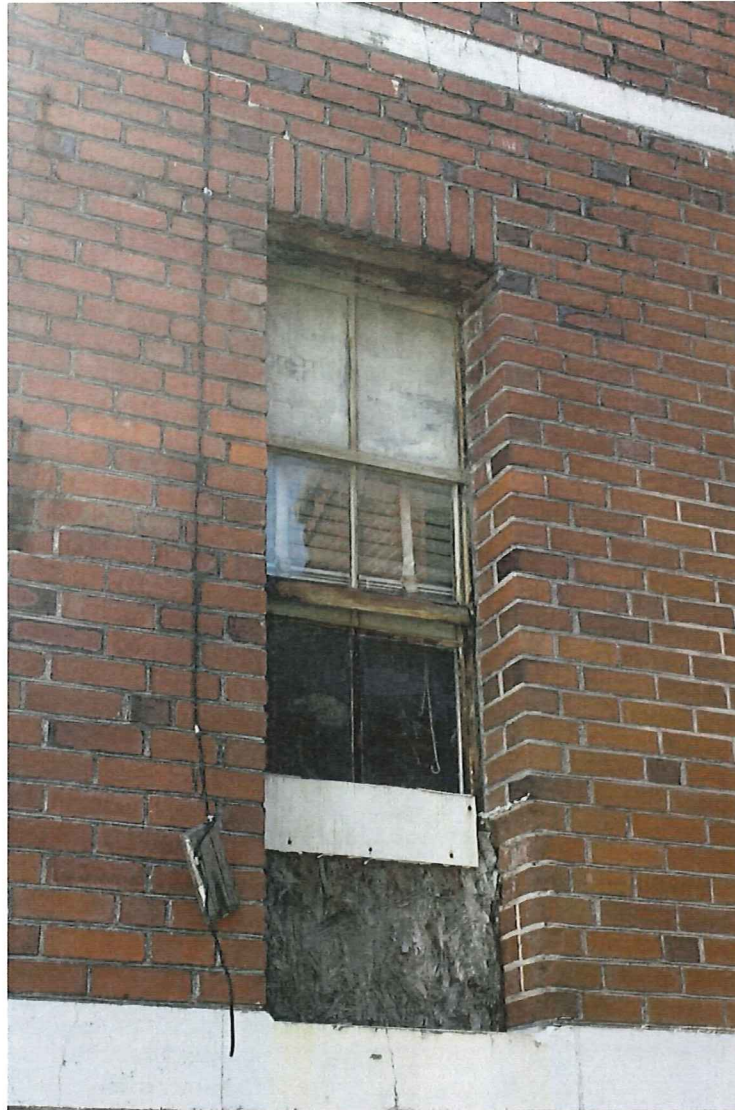
Photo 15 – Deteriorated original eight-light window

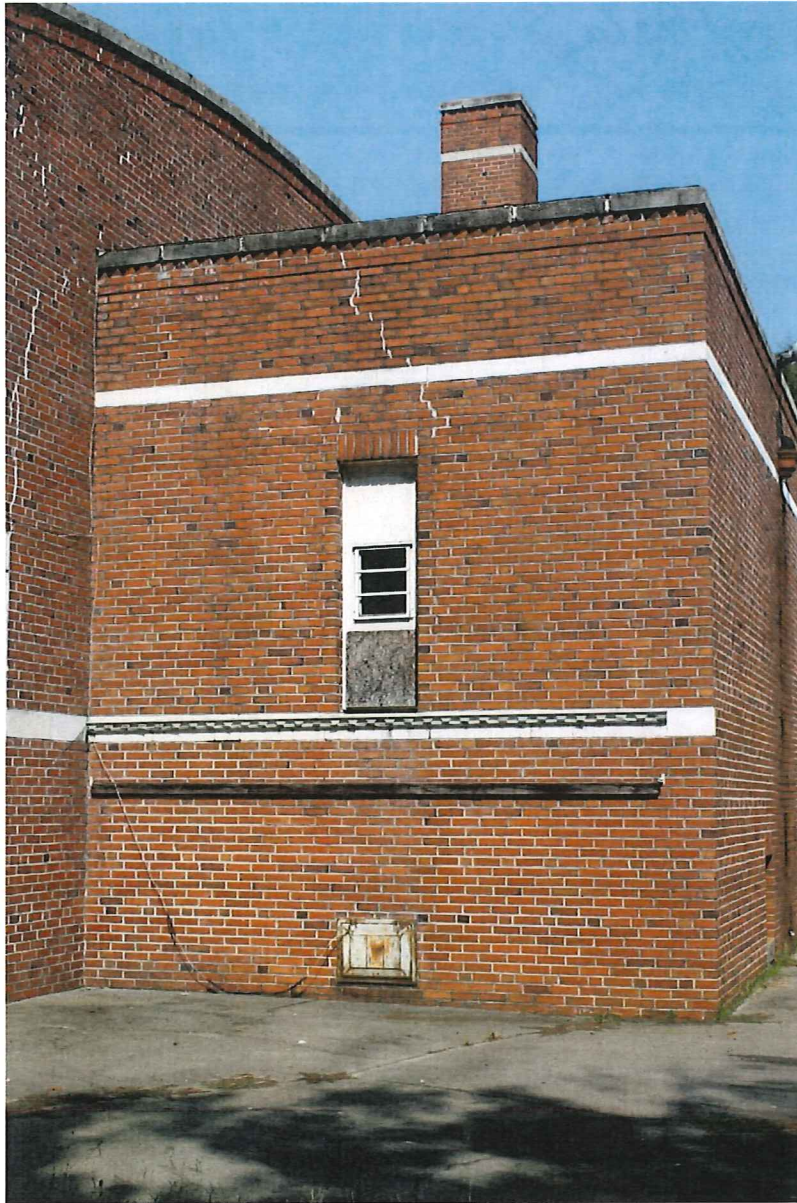
Photo 16 – Replacement window at rear stage, southwest corner

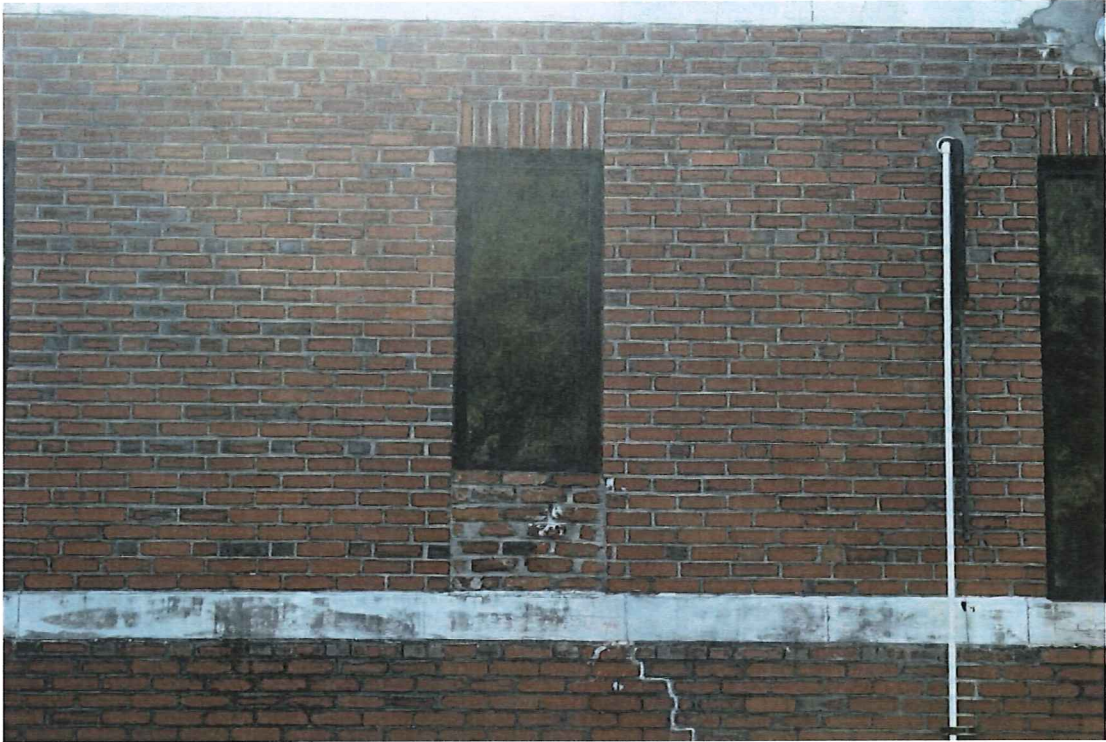
Photo 17 – Post-1994 replacement windows, drill hall

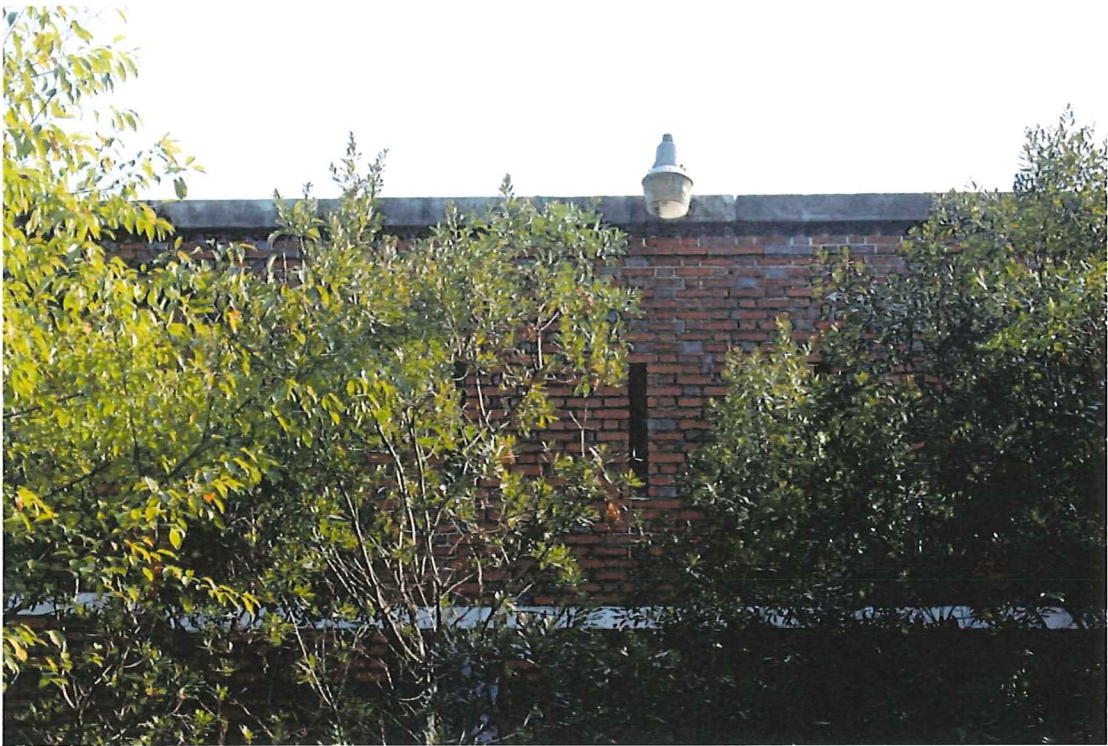
Photo 18 – Front parapet with saw-tooth corbelling and cast stone coping

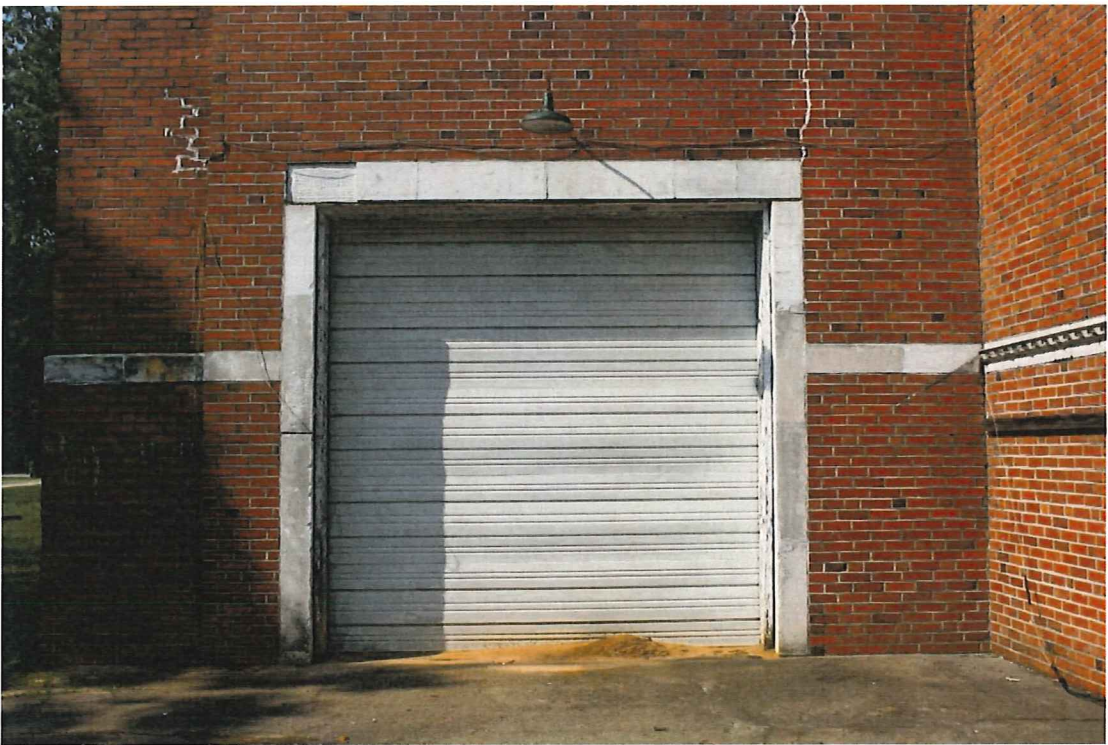
Photo 19 – Garage door at southwest corner

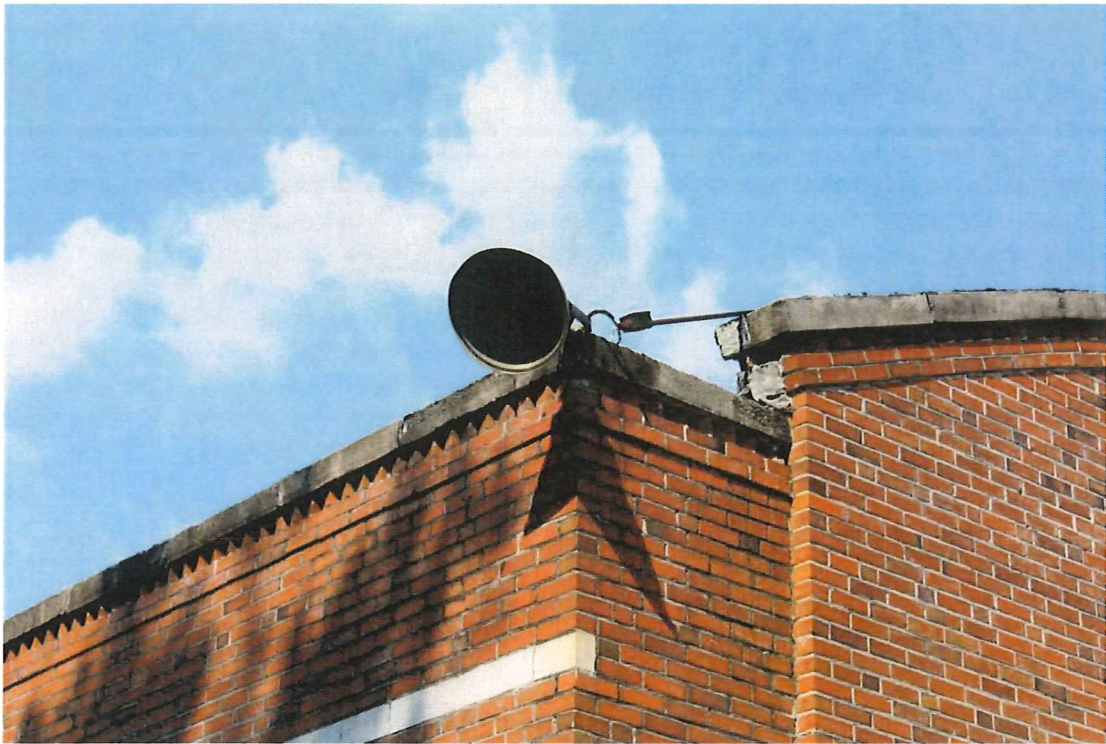
Photo 20 – Siren at southwest corner of building

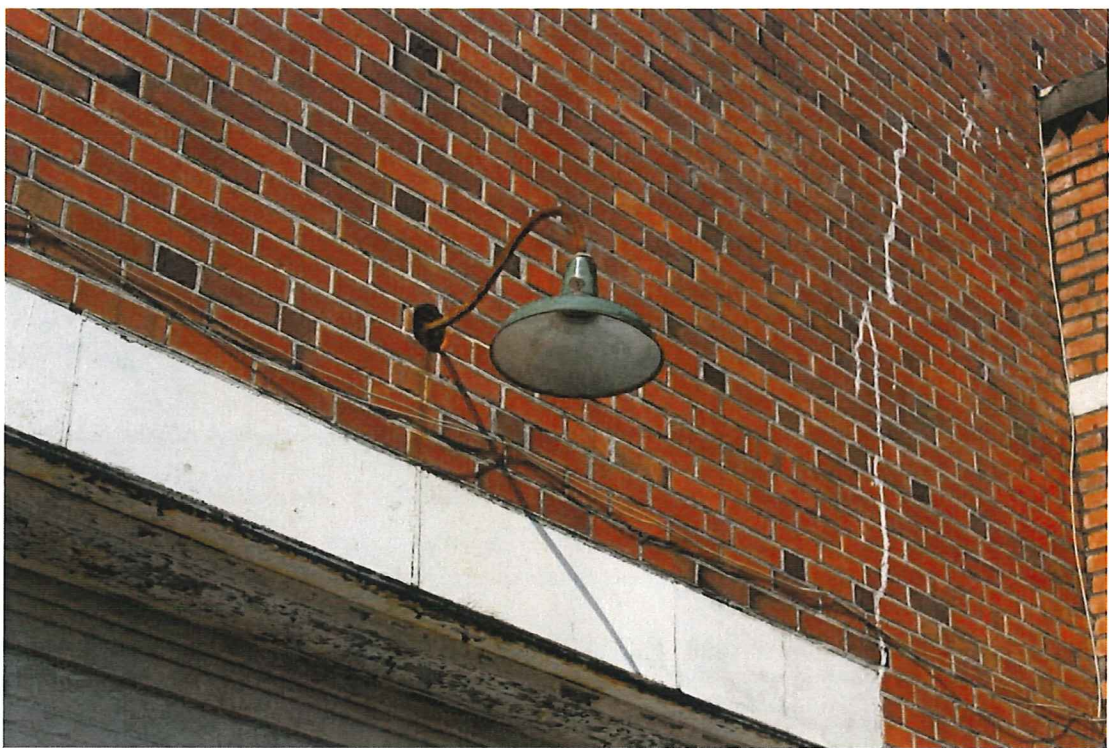
Photo 21 – Gooseneck lamp

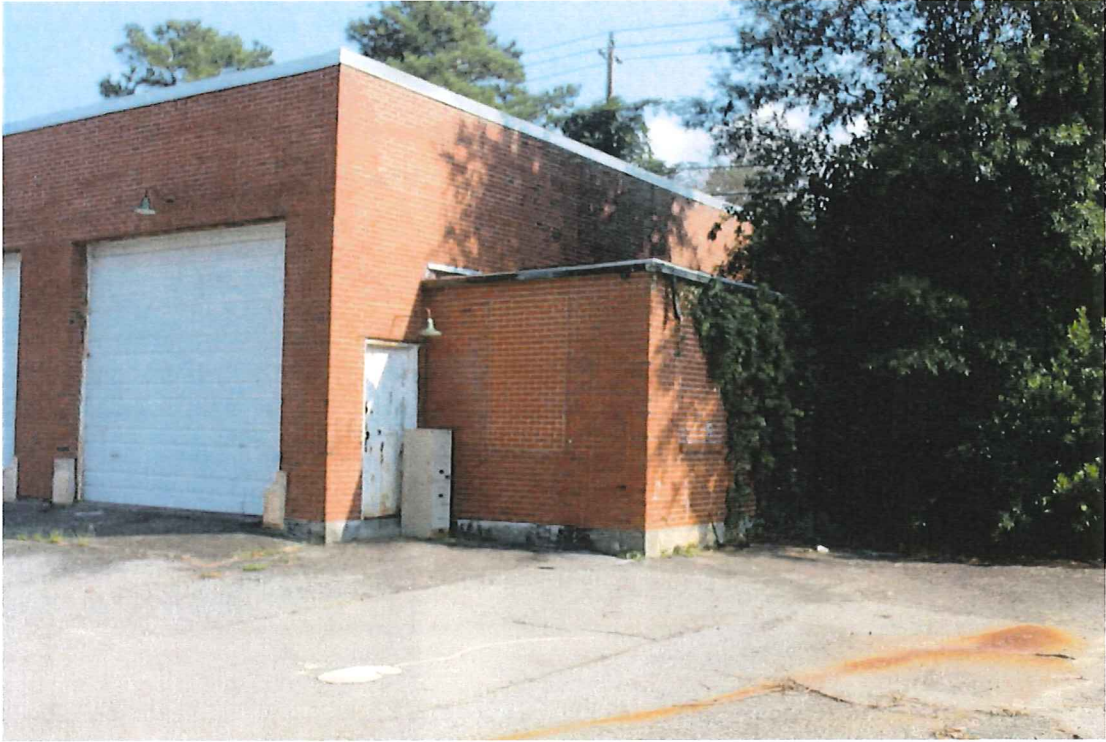
Photo 22 – Southwest corner of garage

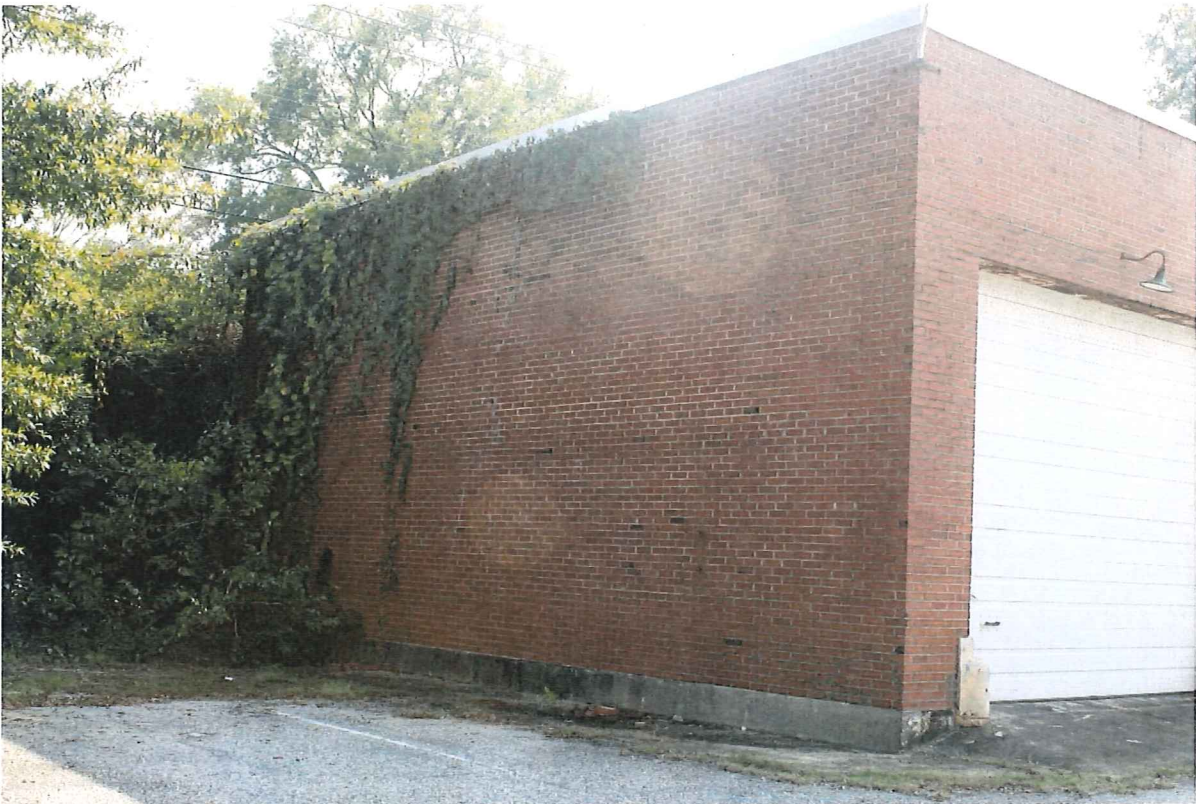
Photo 23 – East elevation of garage

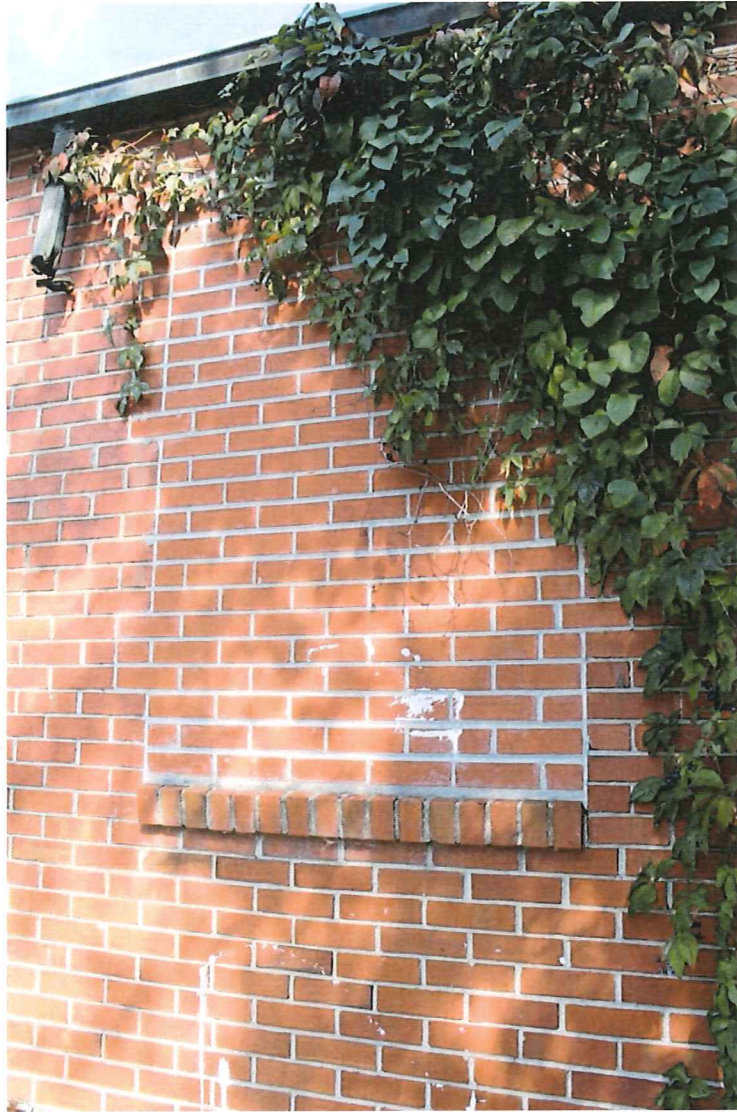
Photo 24 – In-filled window of garage

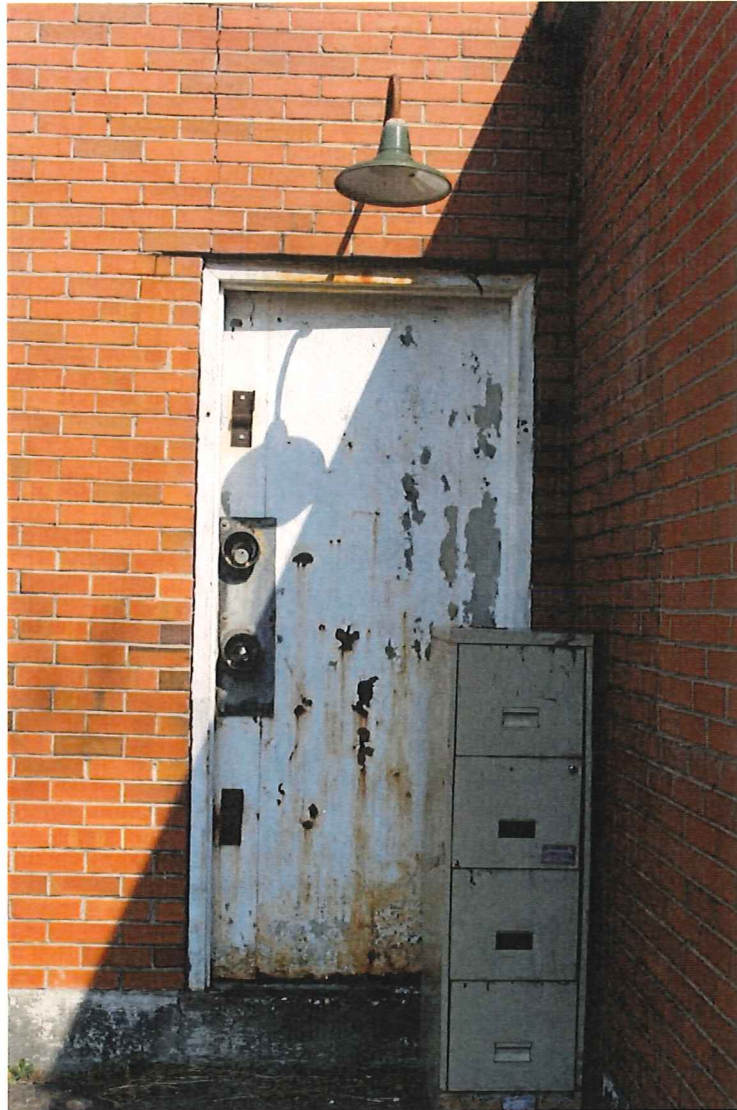
Photo 25 – Pedestrian door to garage with gooseneck light

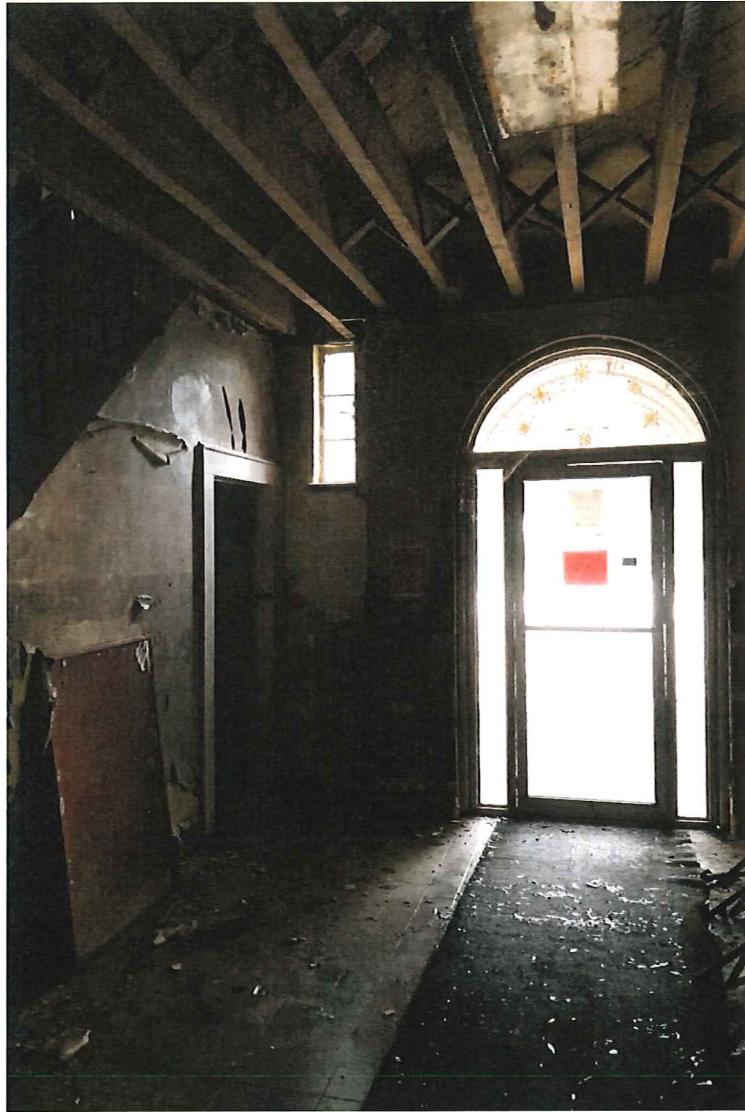
Photo 26 – Front entrance, interior

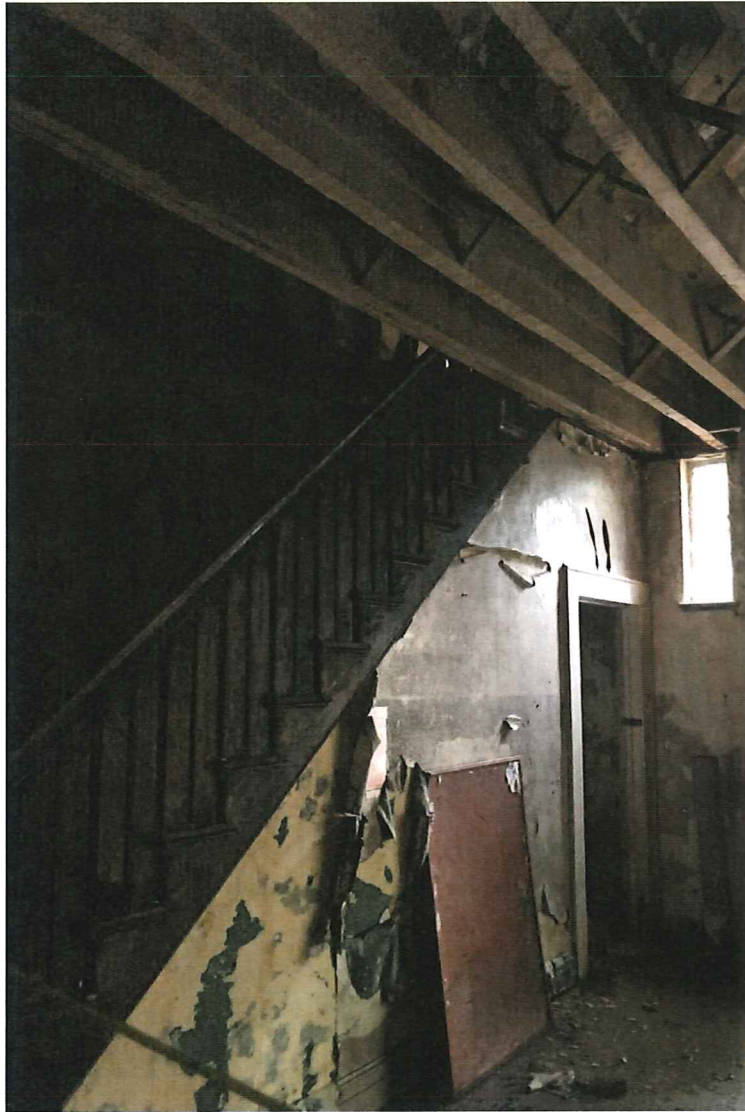
Photo 27 – Stairs
