Part II Photographs – 10/2/2019
Hartsville Armory
559 West Carolina Ave. Hartsville, SC

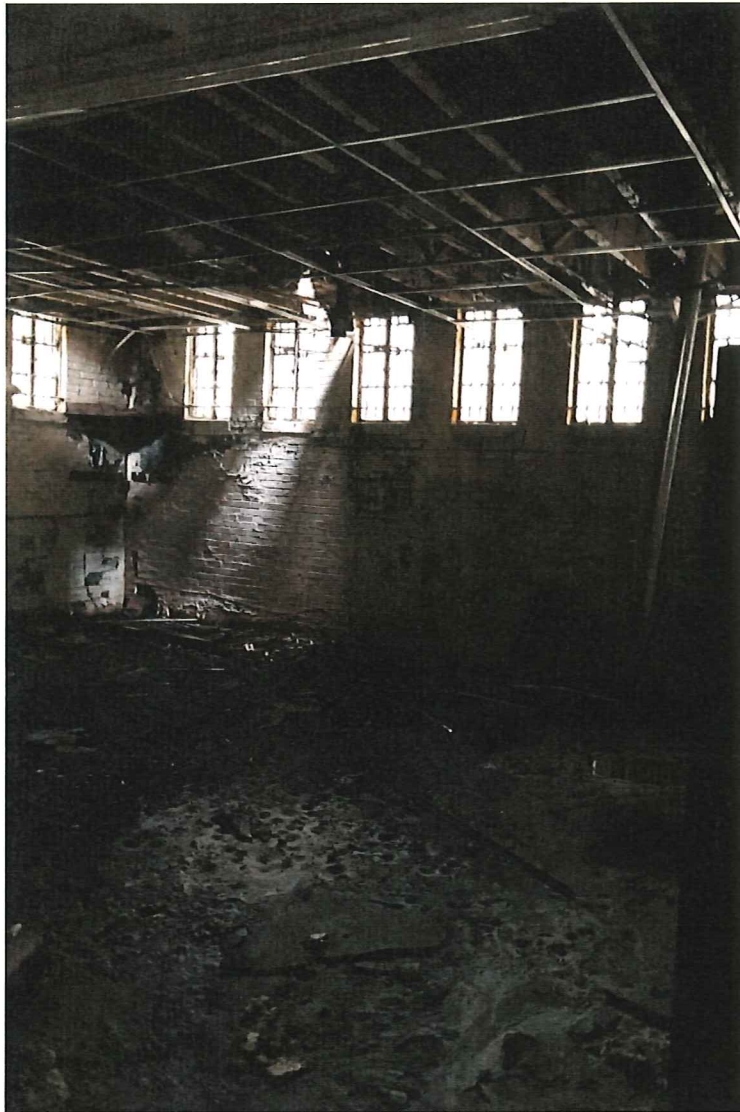
Photo 28 – Northwest corner of administrative section, first floor, looking northwest

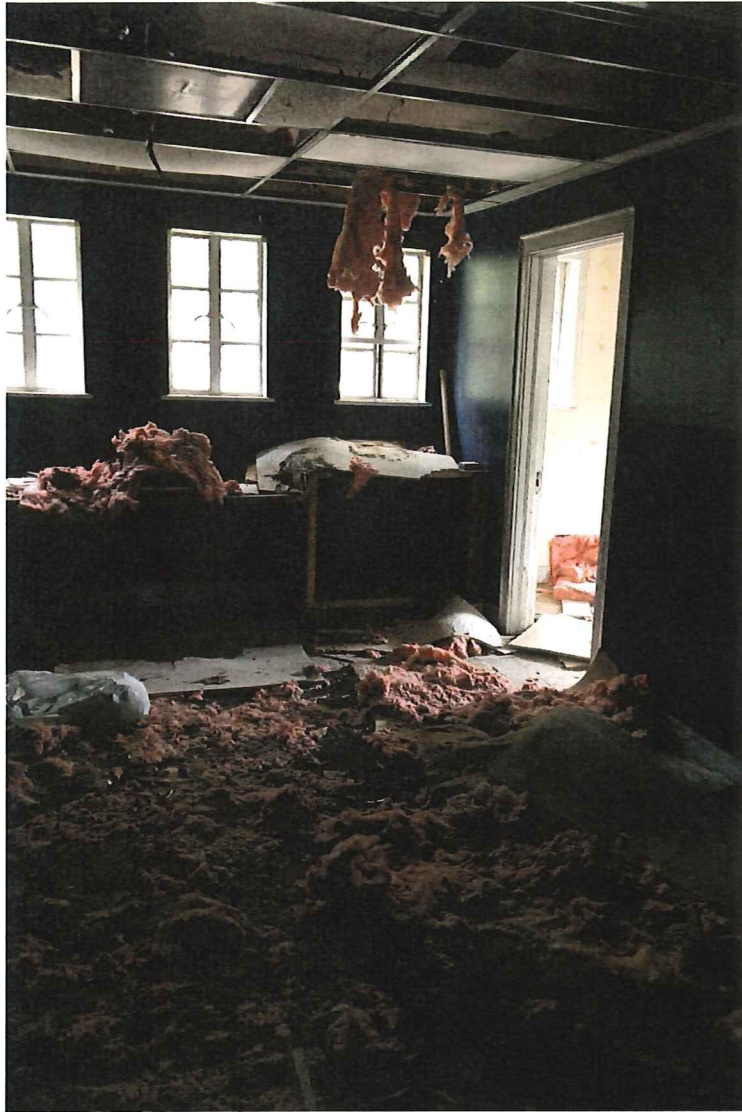
Photo 29 – Second floor office, looking north

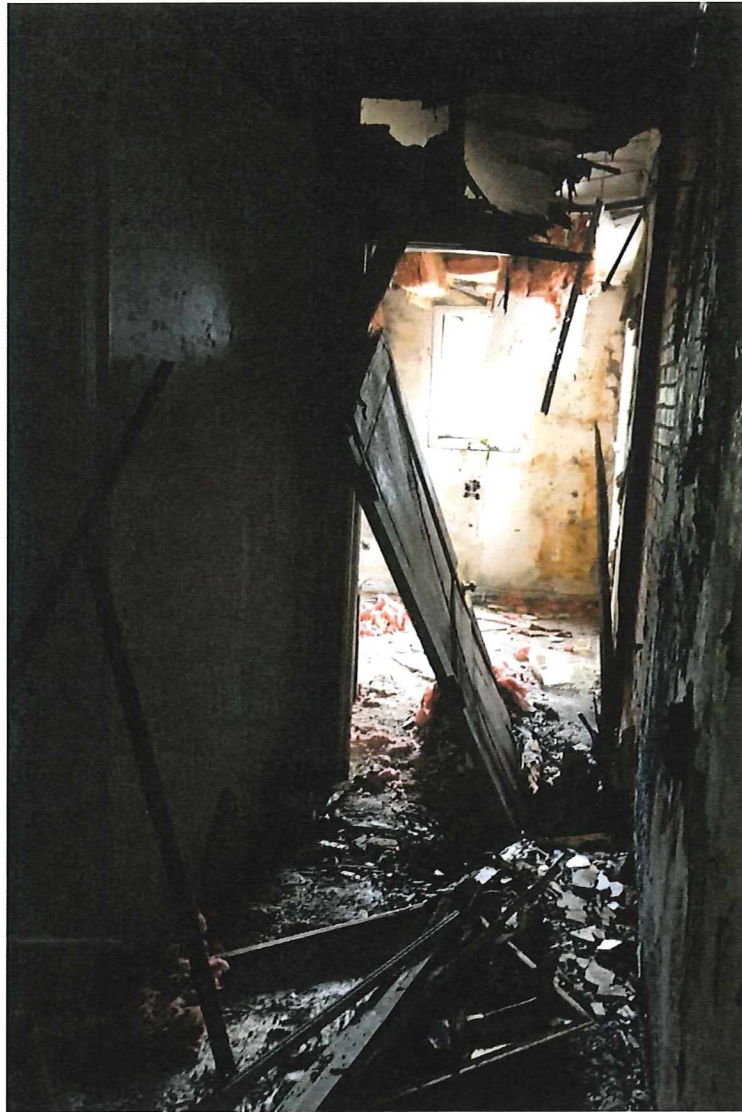
Photo 30 – Second level deterioration in corridor

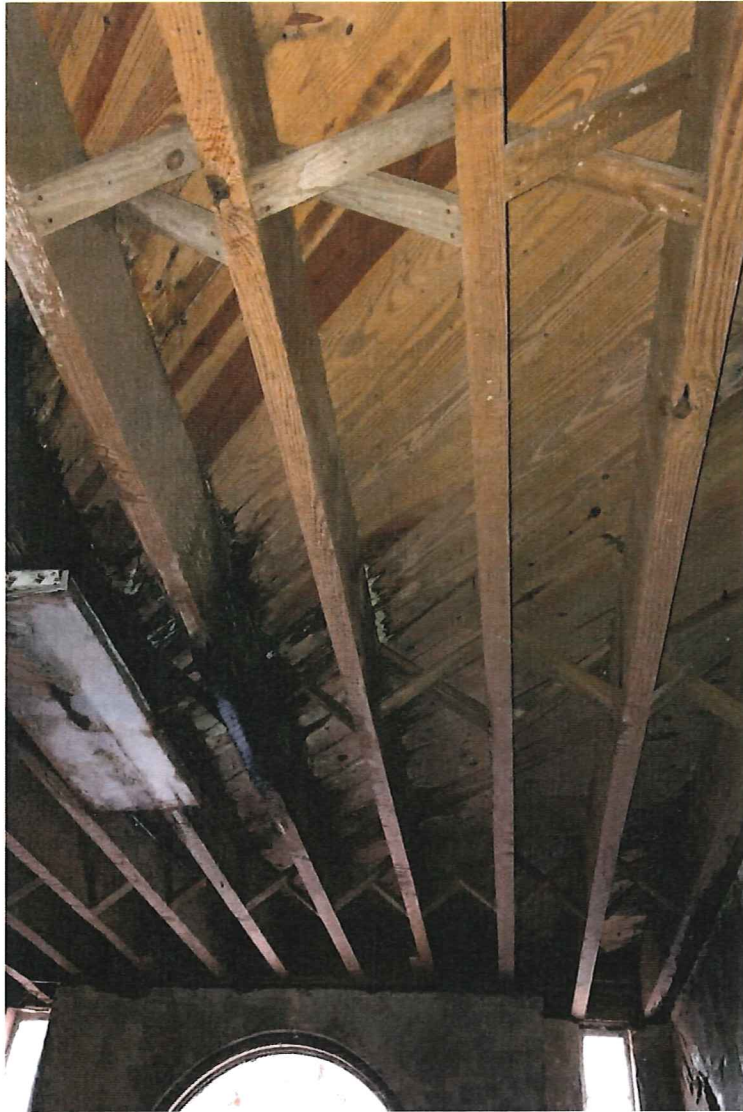
Photo 31 – Missing ceiling of entry lobby

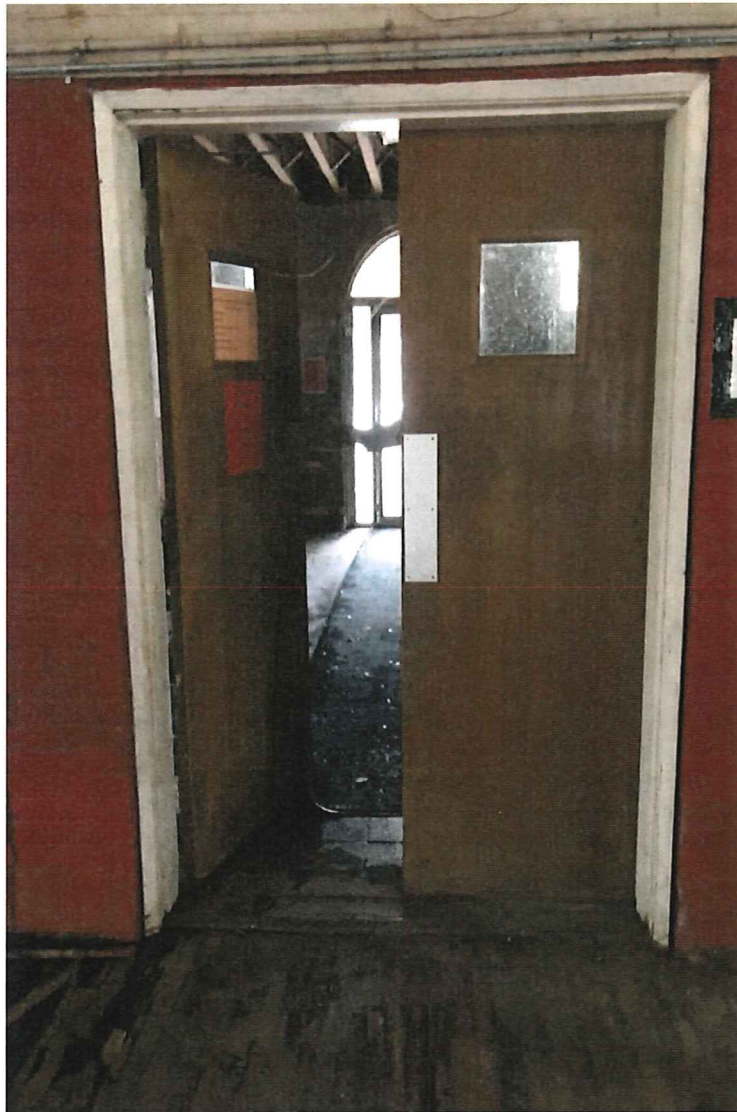
Photo 32 – Doors to drill hall

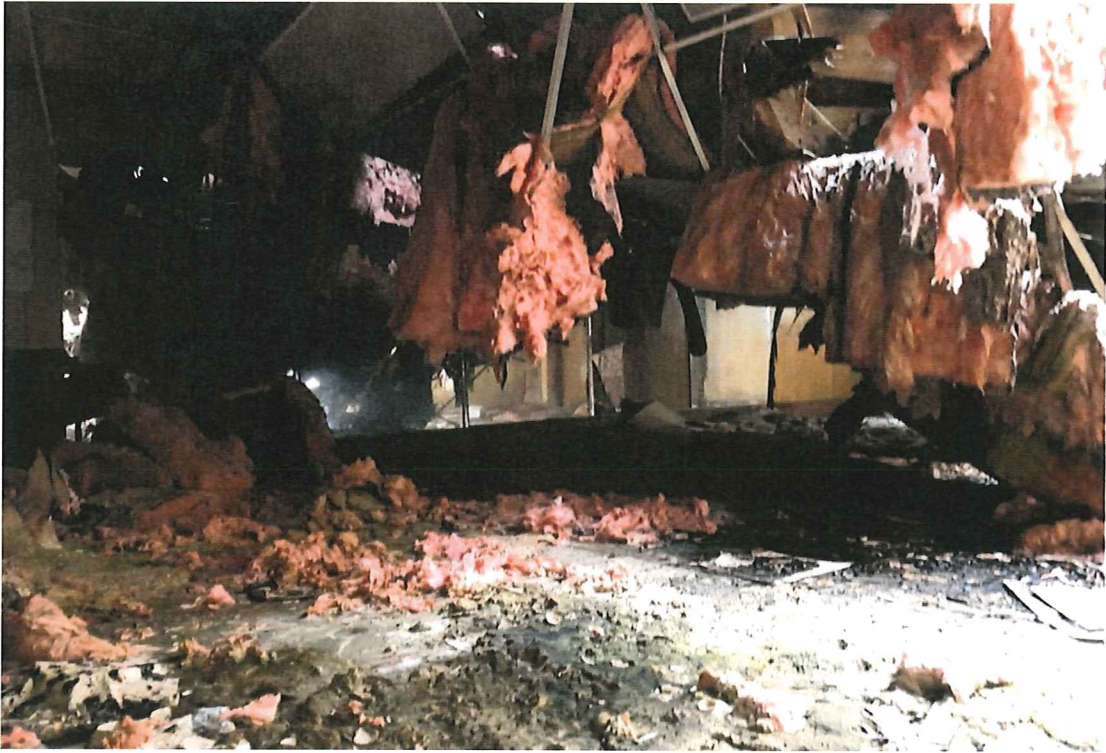
Photo 33 – Second level deterioration

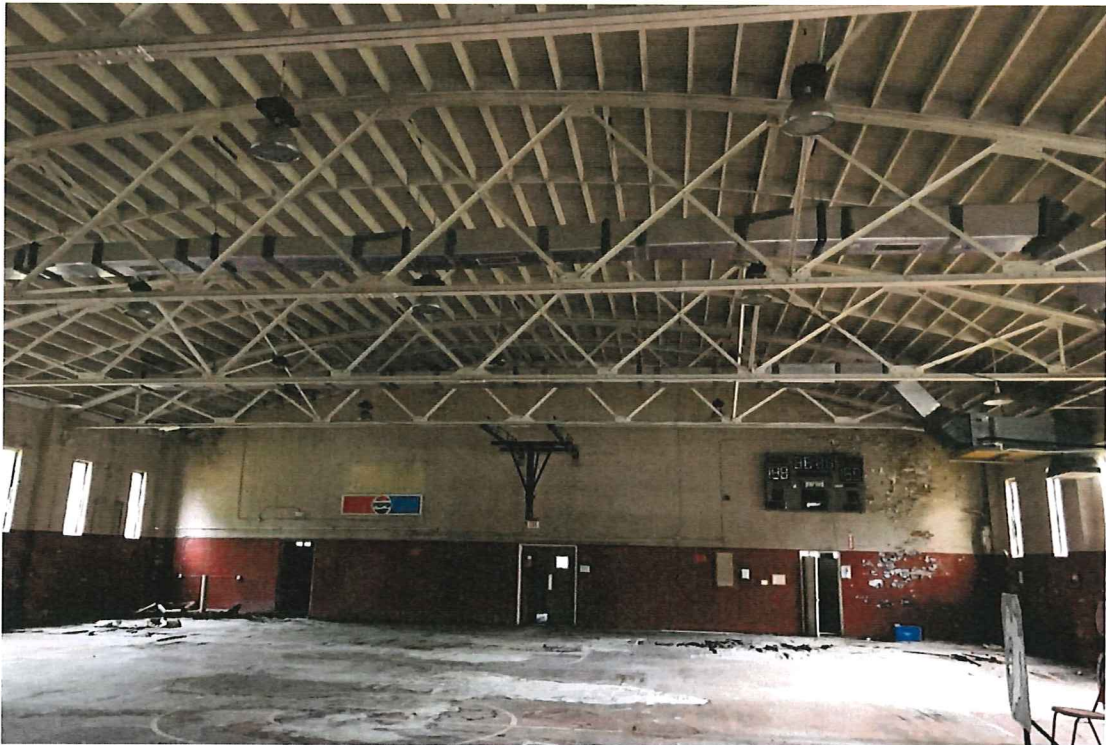
Photo 34 – Drill hall looking north

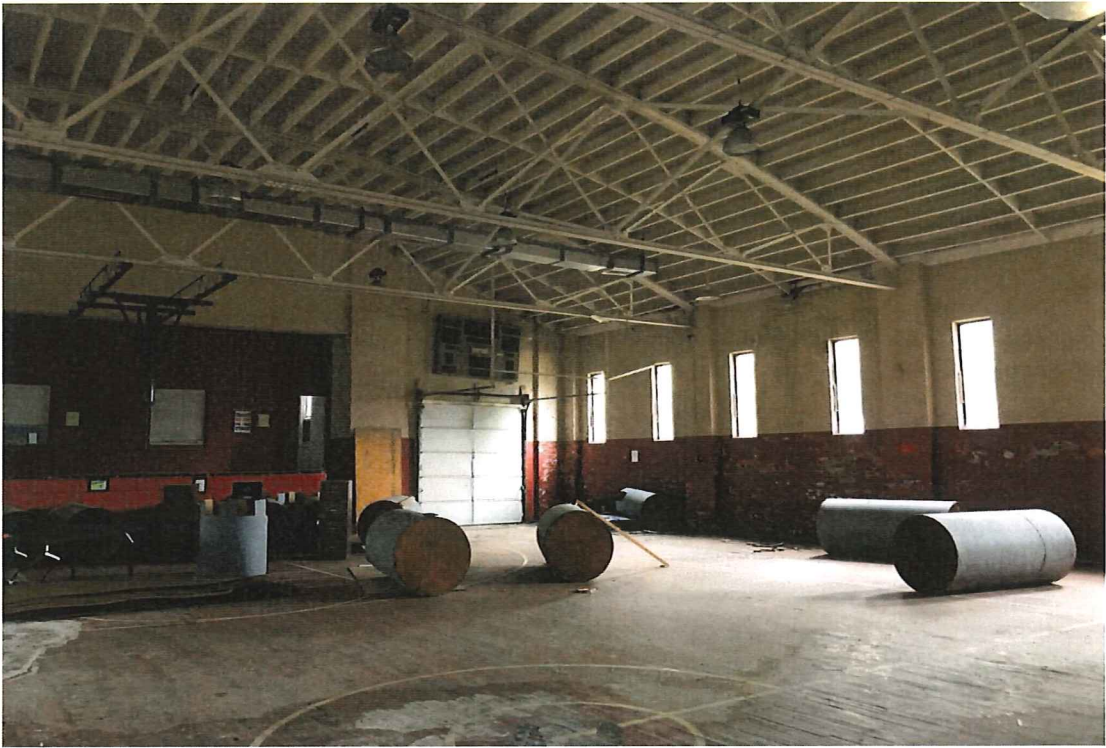
Photo 35 – Drill hall with garage door, looking southwest

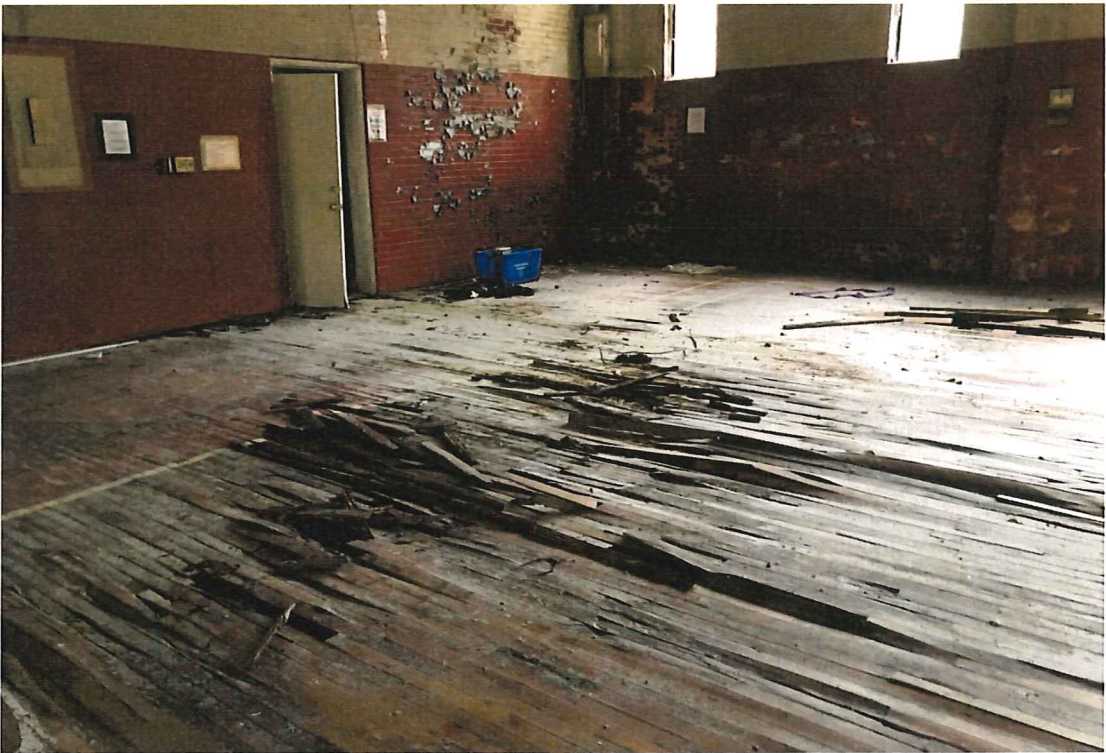
Photo 36 – Deteriorated c.1981 floor, drill hall

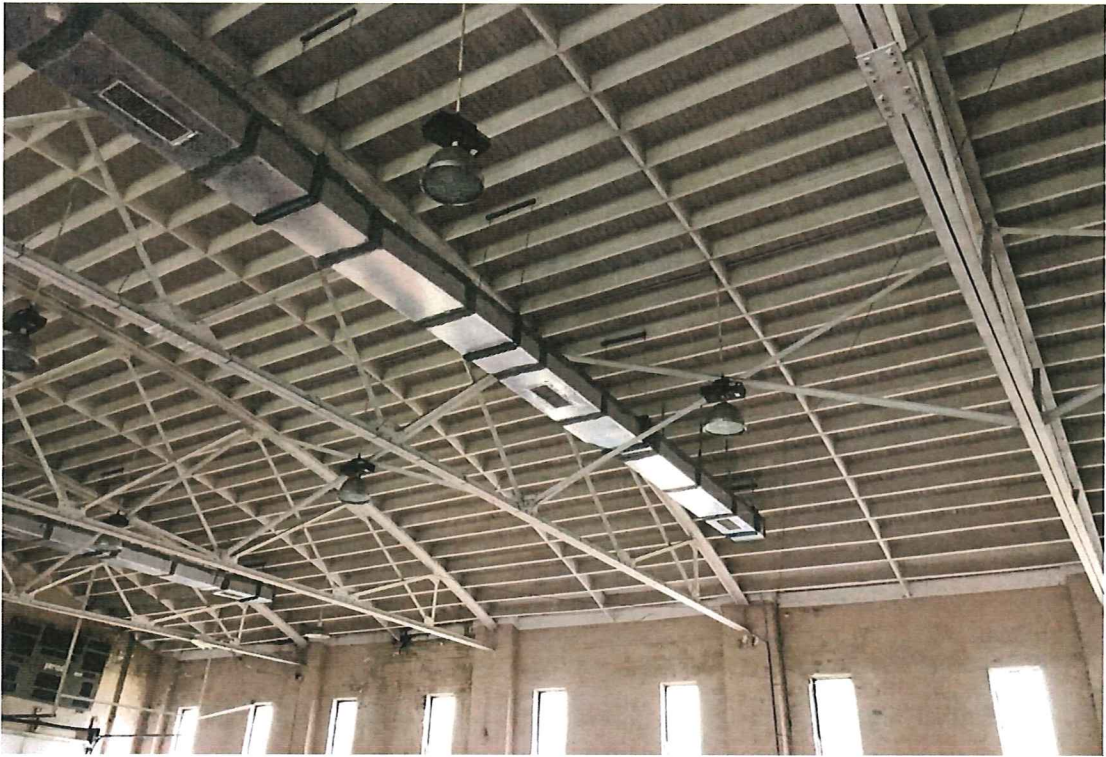
Photo 37 – Exposed trusses in drill hall

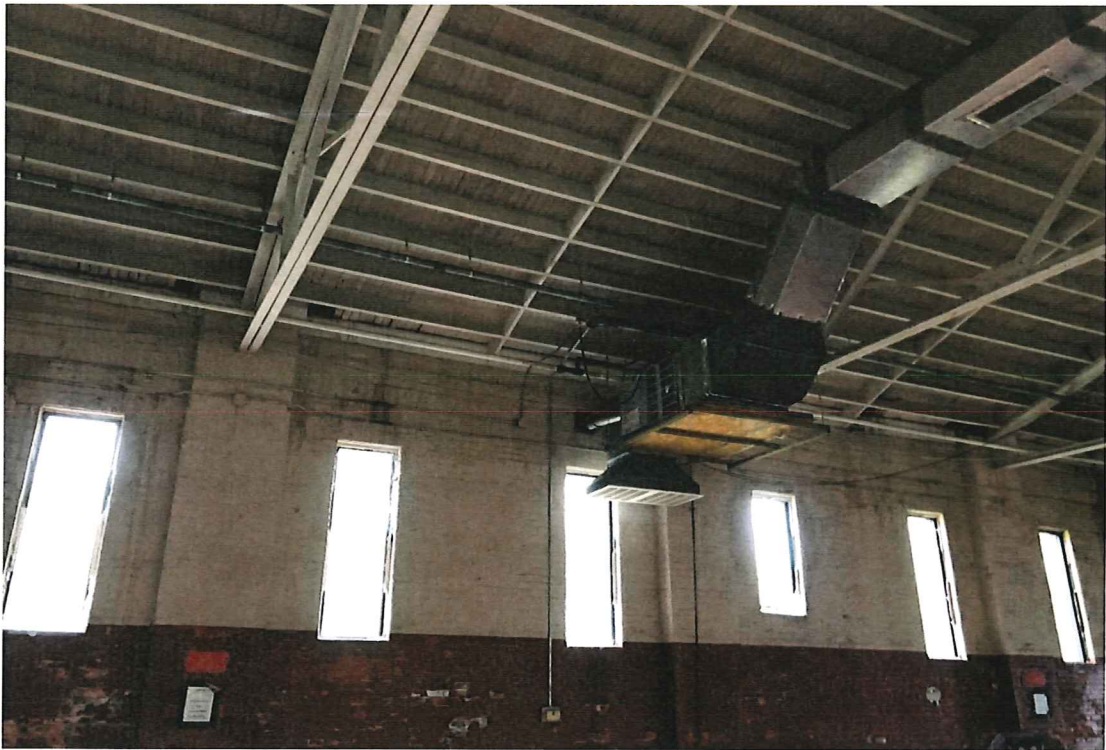
Photo 38 – HVAC unit penetrating wall, drill hall looking east

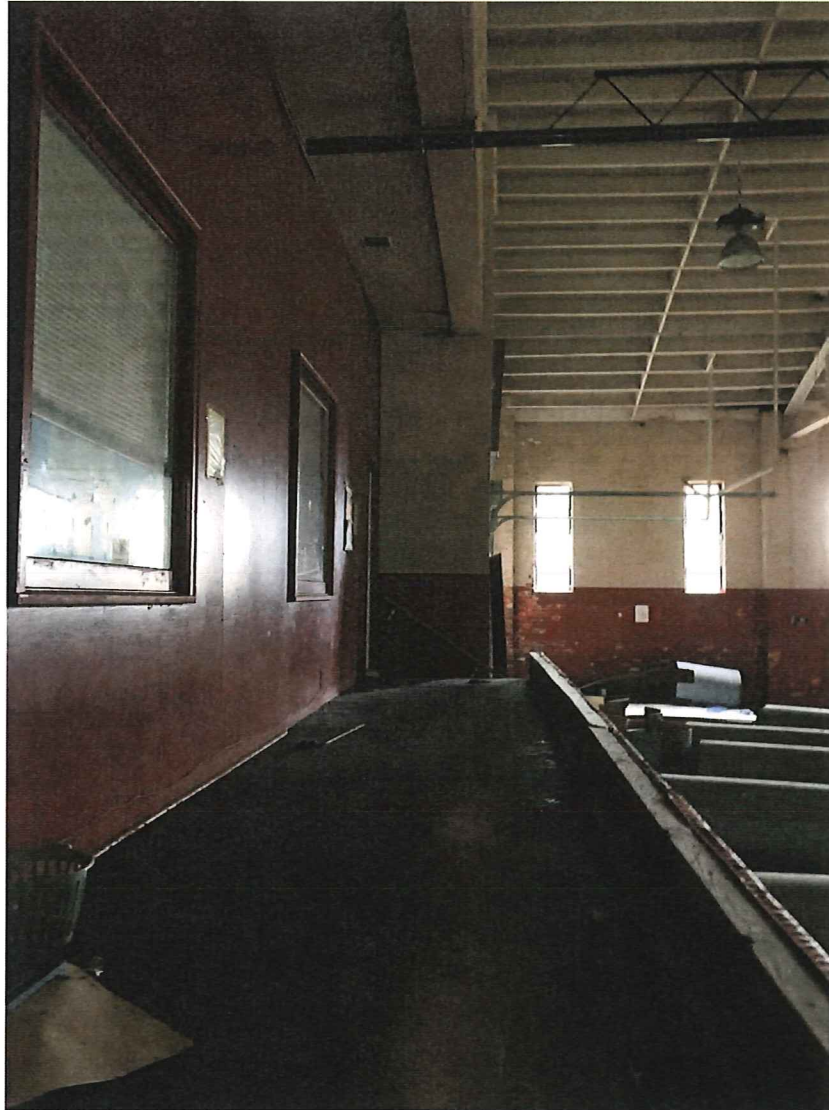
Photo 39 – South end of drill hall at stage, looking west
